Inspection Report

Mine Name: Levan Chicken Creek
Operator Name: Sunroc Corp. - Tony Christofferson

Permit number: M0230016

Inspection Date: 04/09/08

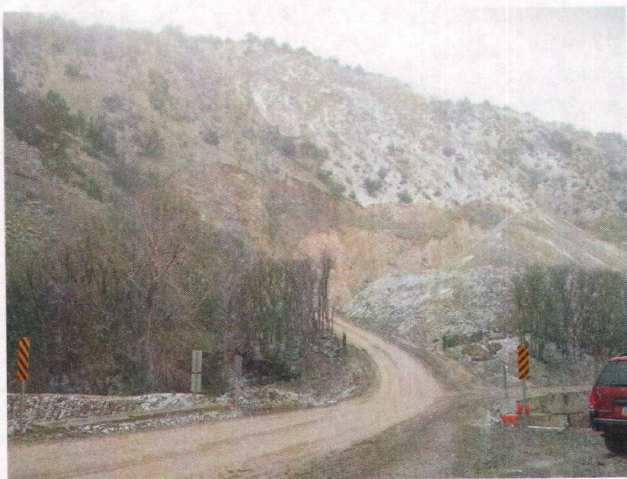
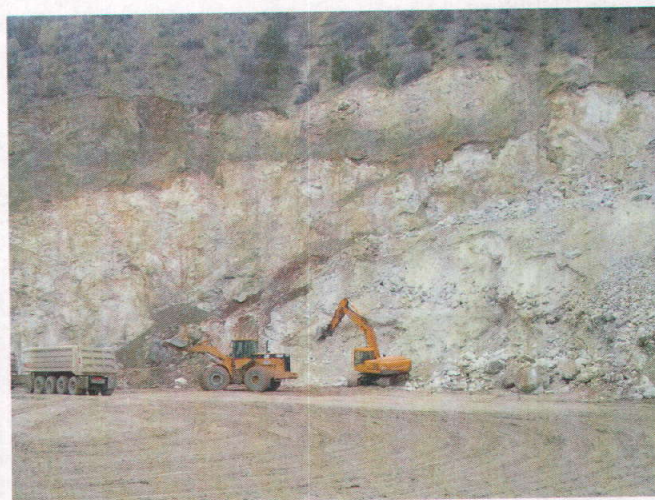
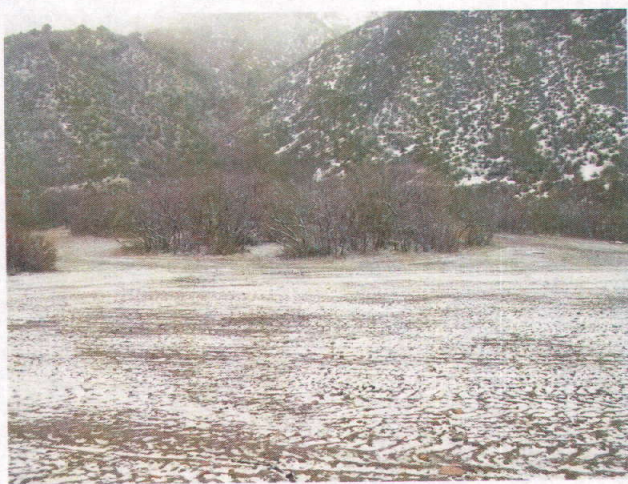
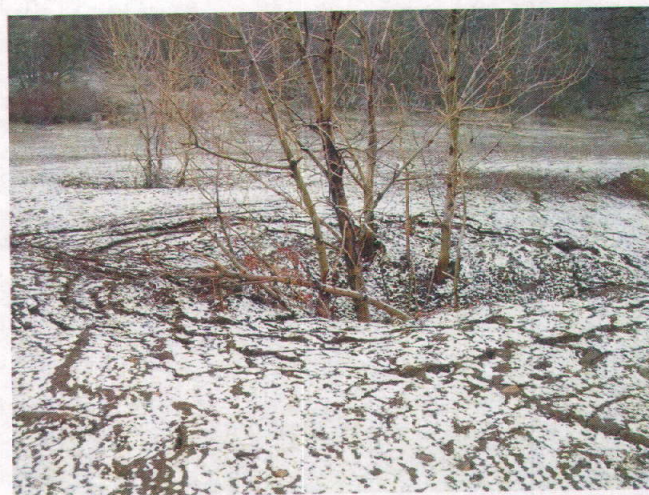
Photos Taken 04-09-08

Inspection Summary: Blast warning signs (one at west and one at east end) of main access road had different dates. Localized highwall failure on east side of the pit. Small debris flow on main access road east of section 34 mine pit. Section 34 mine pit was actively hauling from stockpile placed at the base of the highwall, +5 end dumps in the que. Stockpile was not well sorted and trackhoe was used to size sort large boulders. Area southwest of Section 33 pit was reclaimed, but is/was outside of permit area. Section 33 mine pit was not inspected; a inspection is still needed for the Section 33 mine, when weather/road conditions permit. See attached photos.
